Manhole Inspection Summary

Manhole # S41I2_006MH

Insp Date: **3/31/08 10:19 AM**

Location Address: **4603 Virginia Ave.**

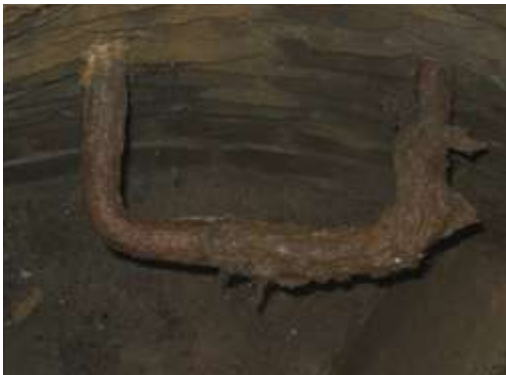
steps

Count: **1** Missing: **0** ☒ **Corroded**

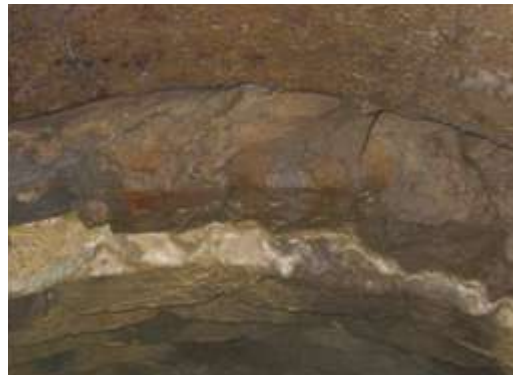
Defect 1

Condition: ☐ Sound ☐ Cracked ☐ Root Intrusion ☐ Loose Brick ☒ **Deteriorated**

Infiltration: ☐ None ☒ **Joint** ☐ Cracks ☒ **Mortar** ☐ Roots ☒ **Wall**

loose bricks and mortar on chimney

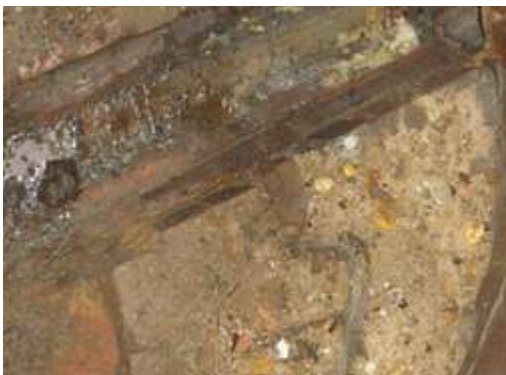
Defect 2

Condition: ☐ Sound ☐ Cracked ☐ Root Intrusion ☐ Deteriorated ☐ Leaks ☒ **Debris**

Debris on the bench and channel

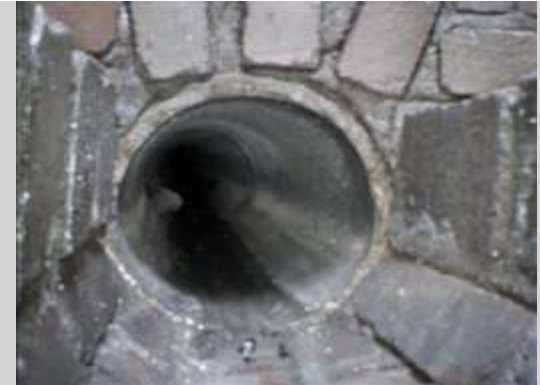
12 O'Clock Outflow

Pipe Height: **8.4** (in.) Rod and Bar (Angled)
Pipe Material: **Clay** ☐ Pipe Lined
Invert Depth: **5.36** (ft.) Flow Characteristics: **Slow**
Deposits: ☒ None ☐ Mud ☐ Sludge ☐ Debris ☐ Grease
Silt Depth: (in.) Deposits Extent:
Infiltration: **None** Pipe Seal Cond: **Sound**

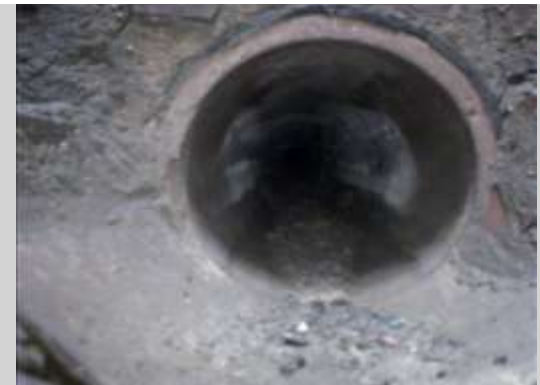
4 O'Clock Inflow

Pipe Height: **7.2** (in.) Rod and Bar (Angled)
Pipe Material: **Clay** ☐ Pipe Lined
Invert Depth: **5.16** (ft.) Flow Characteristics: **None**
Deposits: ☒ None ☐ Mud ☐ Sludge ☐ Debris ☐ Grease
Silt Depth: (in.) Deposits Extent:
Infiltration: **None** Pipe Seal Cond: **Sound**

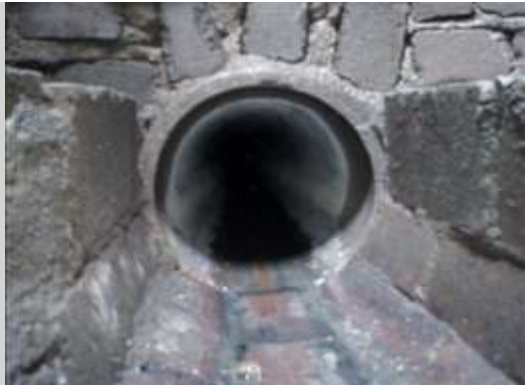
6 O'Clock Inflow

Pipe Height: **8.4** (in.) Rod and Bar (Angled)

Infiltration: **None** Pipe Seal Cond: **Sound**
